## **Anatomy of an Energy Efficient Electric Motor Repair**

*Abstract: A motor repair customer must work closely with a motor repair center to ensure that the equipment sent out for rewind repair is handled in a manner that does not reduce efficiency or reliability. This article is an updated version of a February 1997 IEEE Electrical Insulation Magazine paper based upon the author's work on energy efficient electric motor repair with both the US Department of Energy and Canadian Electrical Association while the Director of Field Service and R&D for Dreisilker Electric Motors, Inc. in the early to mid-1990's and the Chair of the IEEE Chicago Section Chapters of Dielectrics and Electrical Insulation Society and Power Electronics Society as well as the Region 4 (Midwestern USA) representative to the IEEE USAB Energy Committee (IEEE's Federal Government Policy Arm).*

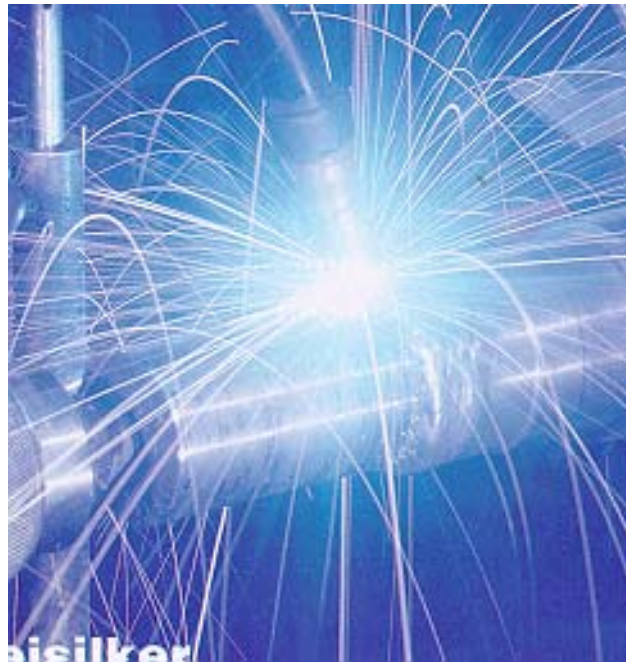
Figure 1: Welding the Fit on a Shaft

- Welding: similar to metalizing. However, it creates a stronger metal-to-metal bond when properly applied. If a repair requires adding metal, this is the preferred method as compared to metalizing. However, significant experience is required in order to prevent stress fractures in the material.

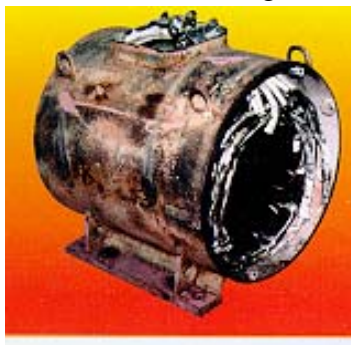
- Direct Flame: A flame from a torch or other source is directed onto the core and winding. In some cases, the stator is physically placed in a bonfire! The temperature is uncontrolled and severe damage to the core will occur. The varnish is reduced to ash and the windings removed.
- Burnout: The stator is placed into a burnout oven is set for a recommended temperature of 650°F (345°C). It is kept at this temperature until all of the varnish and insulating materials are turned to ash (eight or more hours). If the temperature exceeds this value, damage to the stator core and frame distortion may result, reducing motor efficiency, mechanical reliability and increasing soft-foot. Gasses and other byproducts are exhausted through a ‘smoke stack’ into the atmosphere.

Figure 2: Stator that has been through the burnout process

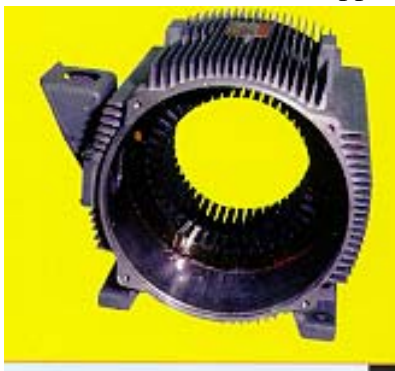
- Mechanical Stripping (Dreisilker/Thumm Method): Using a heat source, such as gas jets, a distance away from the core, the back iron and insulation is warmed until the windings become soft and pliable (approximately 10°C above the insulation class of the varnish insulation). The coils and insulation are removed using a slow, steady hydraulic pull. Temperatures remain low, stripping times extremely fast (ie: 2.5 hours for a 350HP motor), and there are no significant airborne byproducts or disposal problems. Attempts at duplicating this process using pneumatic pulling methods have resulted in core laminations being pulled apart. Therefore, pneumatic machines of this type should be avoided.

Figure 3: Dreisilker/Thumm Stripped Stator

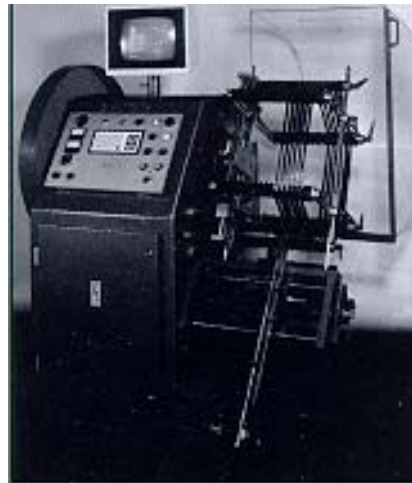
- Hand-Winding: performed with a 'tower-type' winding machine and mechanical counter. The winding technician must try to maintain correct tension and layering of the coils, or the coils will be difficult to lay in the stator slots. In the worst-case, there will be wires crossing, which will increase the turn-to-turn potential in the wire, creating an area that may short under certain operating conditions. Improper tensioning of the coils may cause more wire per phase, changing the impedance balance of the motor windings.
- Automatic coil winding machines: maintain constant tension and proper count of the coils. Still require a technician to observe operation, but will still reduce labor time.
- Computerized coil winding machines: the technician is free to perform other tasks while the machine winds the stator coils. Proper tension and turn count are maintained.

Figure 4: Computerized Coil Winding Machine

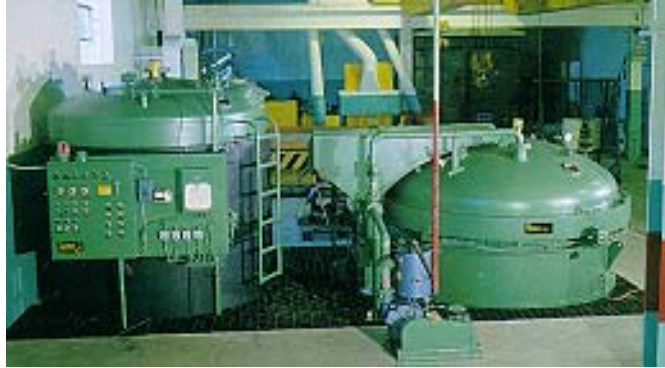
- **Vacuum Pressure Impregnation (VPI):** due to expense, this process is not recommended for low voltage motors but is a must for medium voltage, form wound cores. It consists of a voidless slot fill (as with the trickle method), but requires taping the windings to keep the varnish in between conductors. The stator is warmed in an oven, then placed in a VPI tank where a vacuum is drawn within the tank. Varnish is flushed in from a holding tank and pressure is applied to the tank. Air bubbles within the insulation system that expanded in the vacuum constrict and draw the varnish through insulating tapes. The stator is then placed in an oven to cure.

Figure 7: Vacuum Pressure Impregnation

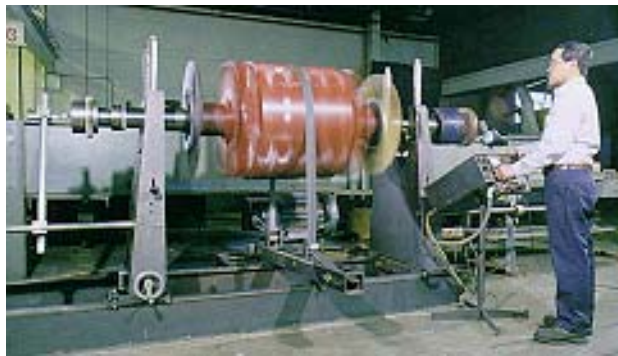
Figure 8: Rotor Balancing
